FRAGILITY OF Pb-FREE SOLDER JOINTS

White Paper
August 20, 2004

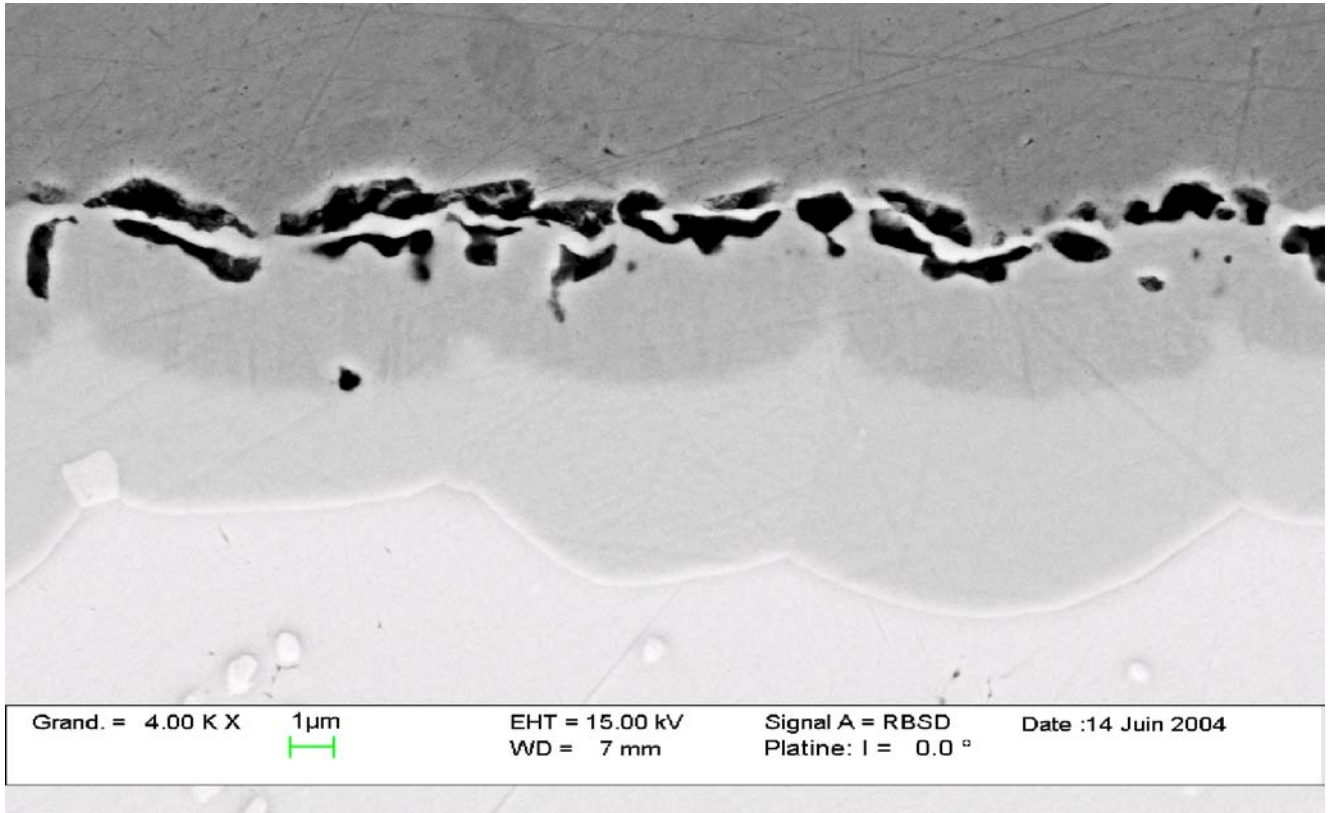
Figure 1: Interface between Sn-Ag-Cu solder ball and Cu pad after 1000 hours at 150°C.

Recent reports of rapid mechanical weakening of Sn-Ag-Cu solder joints on Cu pads in thermal aging have caused considerable stir in the microelectronics packaging community [4, 5]. The effect appeared to be caused by the growth of Kirkendall voids along the Cu₃Sn/Cu interface (Figure 1). Extensive voiding was observed after only moderate aging (20-40 days at 100°C) making it an obvious practical concern, at least for products facing elevated operating temperatures and mechanical shock or vibrations in service. In fact, the apparent temperature dependence might suggest a risk of failure within a few years under even quite mild conditions. The behavior was confirmed independently by others [5, 6], but fortunately this embrittlement problem may be avoidable. Initial experiments by UIC did not reproduce the voiding [7], and work by IBM suggests a dependence on plating lot (Figure 2). These findings may suggest an effect of impurities. In some instances contamination has been shown to strongly enhance Kirkendall voiding, as impurities are less soluble in the intermetallic phases and thus may be 'swept' ahead of the transformation front and precipitate to act as heterogenous nucleation sites for voids [8]. It can, however, also not be excluded that sub-microscopic voids or bubbles were somehow incorporated at the Cu-surface during reflow and subsequently serve as sinks for vacancies.

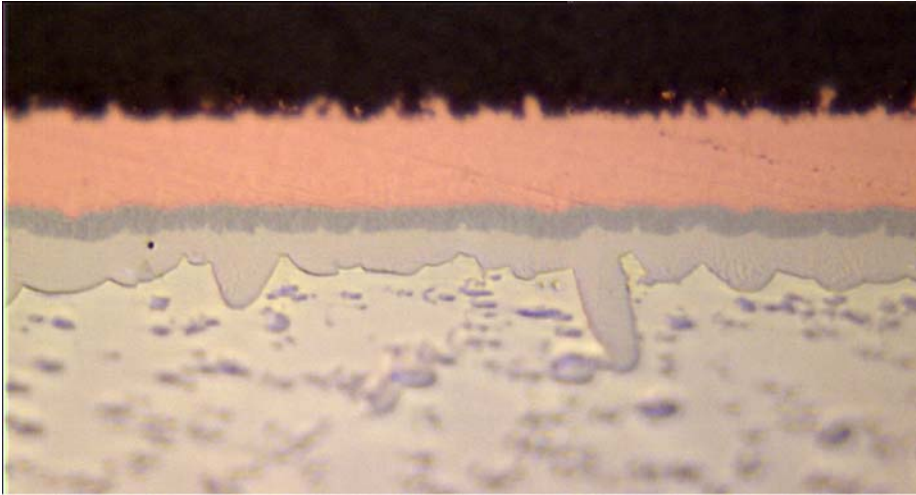
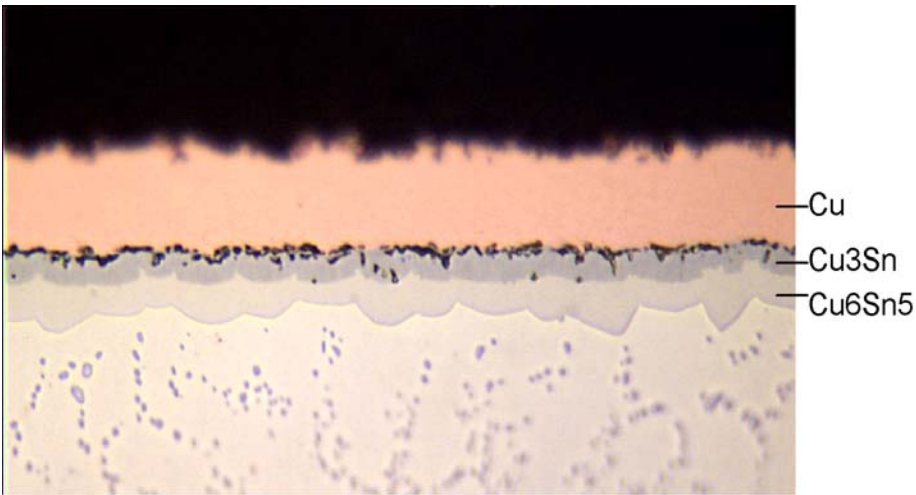
Figure 2: Interfaces between Sn-Ag-Cu solder balls and Cu pads on identically aged samples (1000 hours @ 150°C) from different lots.
